ENGINEERING GEOLOGIC FACTORS
OF THE
MARBLE AREA
GUNNISON COUNTY, COLORADO

WILLIAM P. ROGERS
ENGINEERING GEOLOGIST

JUNE 1972
2ND PRINTING 1977
Price: \$ 2.00

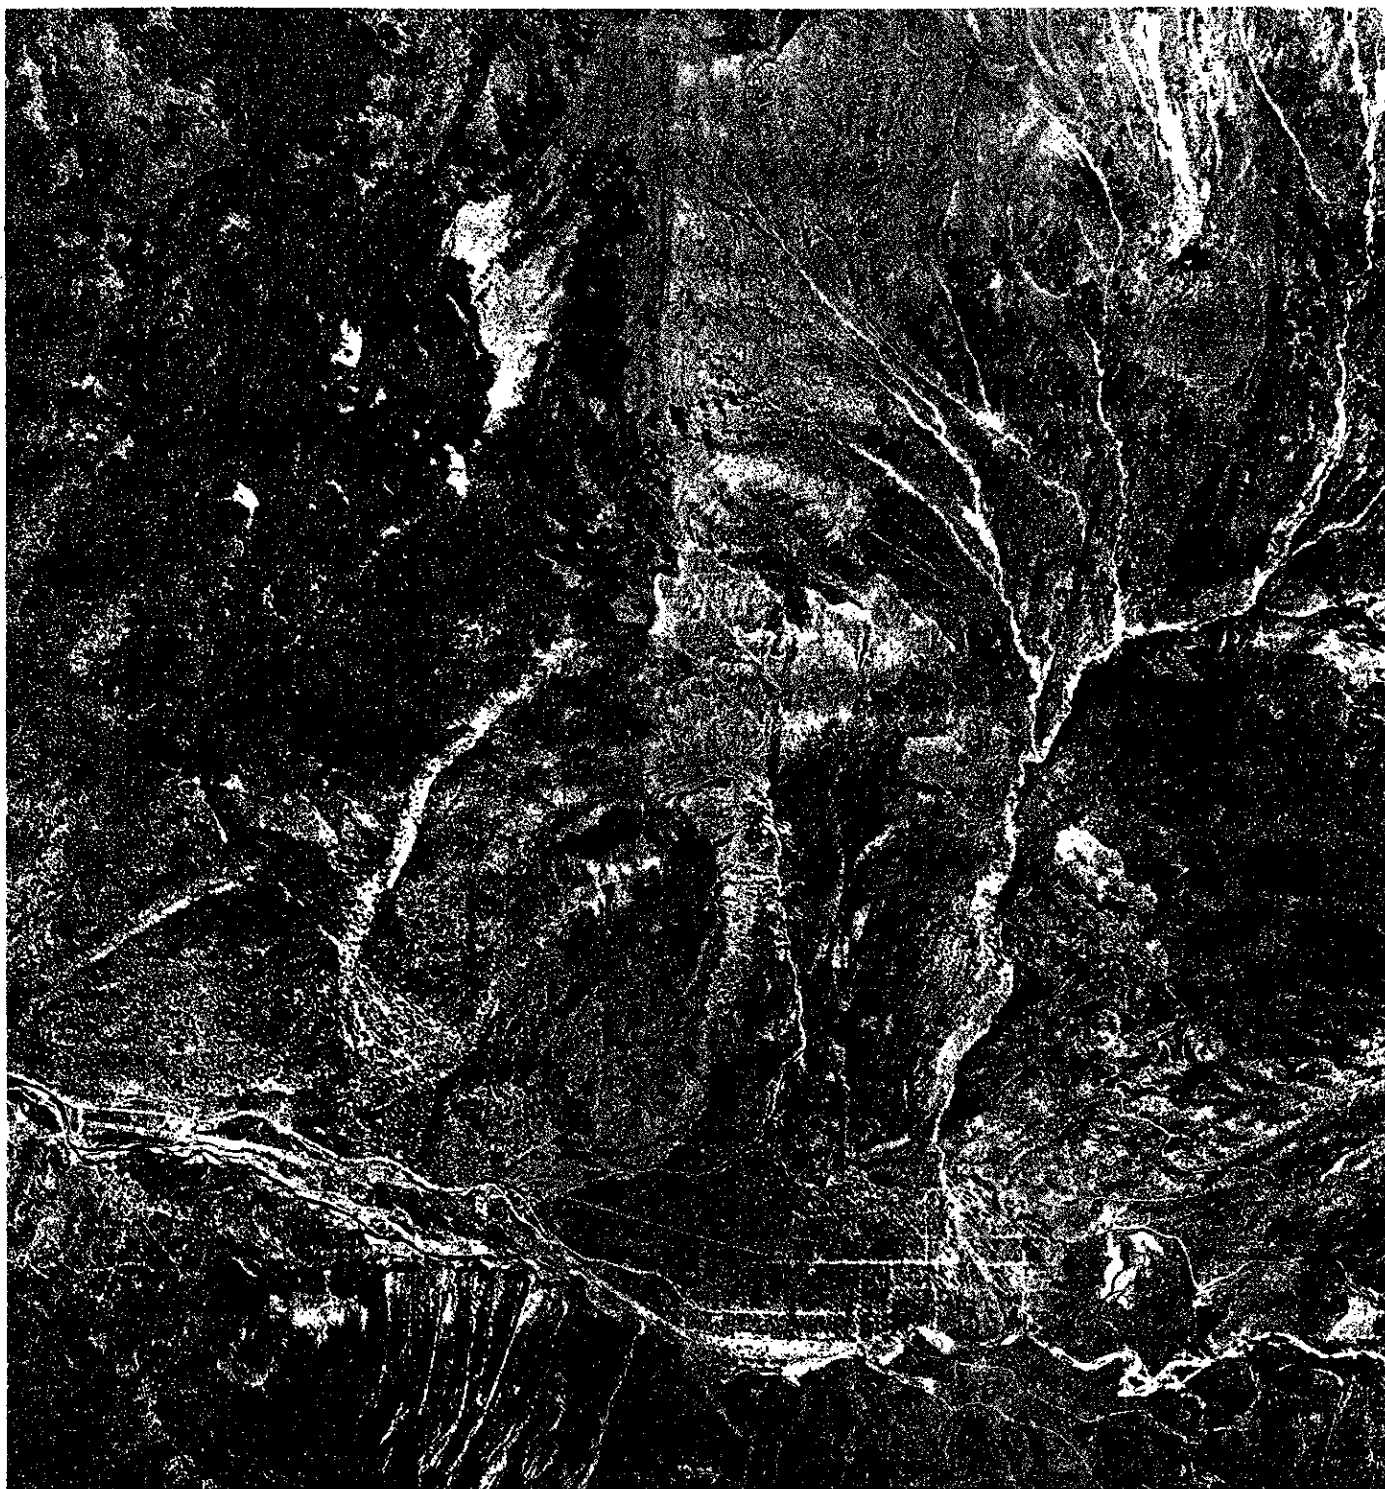
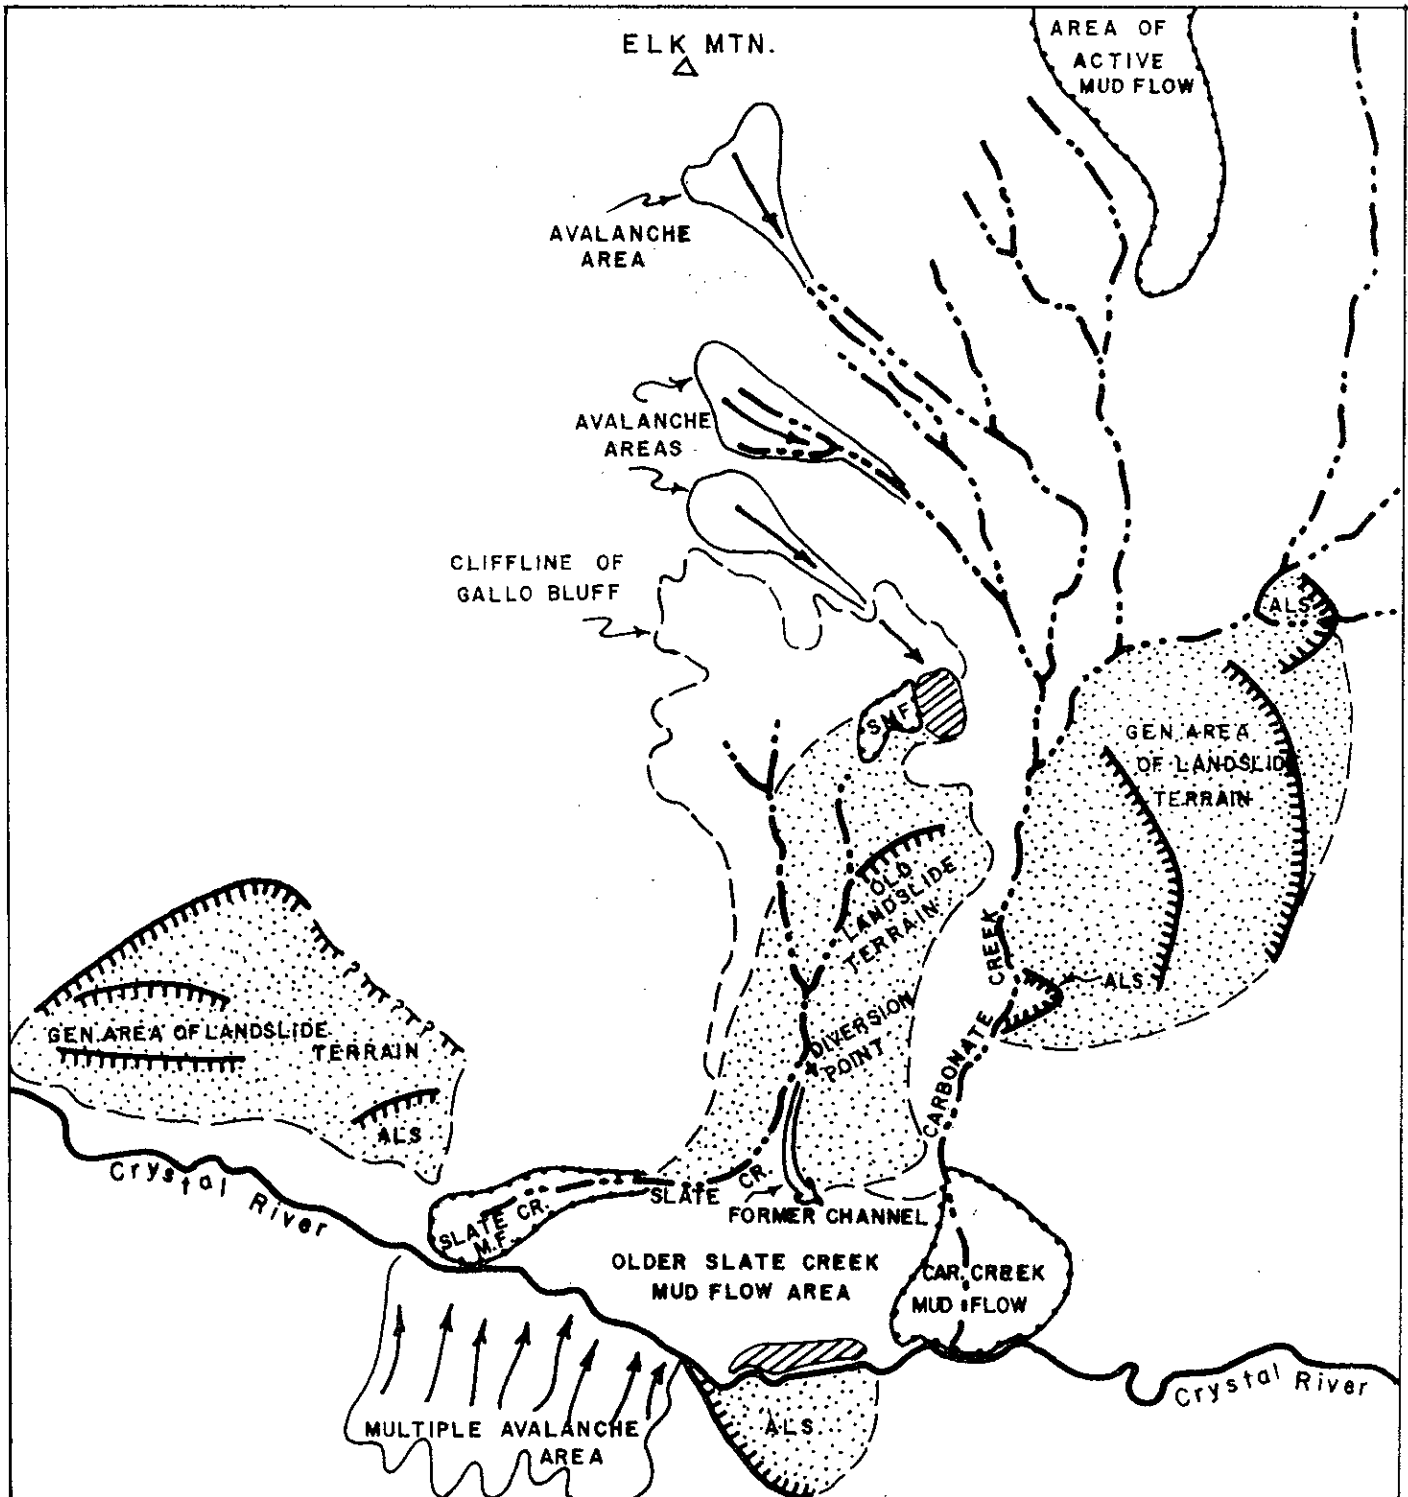
FIGURE 1. PHOTOGEOLOGIC INTERPRETATION OF MAJOR FEATURES

Easily identifiable features recognizable from photograph on facing page are shown in line drawing below. Symbols not self-explanatory are listed below.

ALS indicates areas believed to be active landslides.

Heavy Arrows indicate snow avalanche chutes, and Diagonal Pattern shows identifiable landing areas.

SMF indicates area of small mudflows at base of Gallo Bluff.

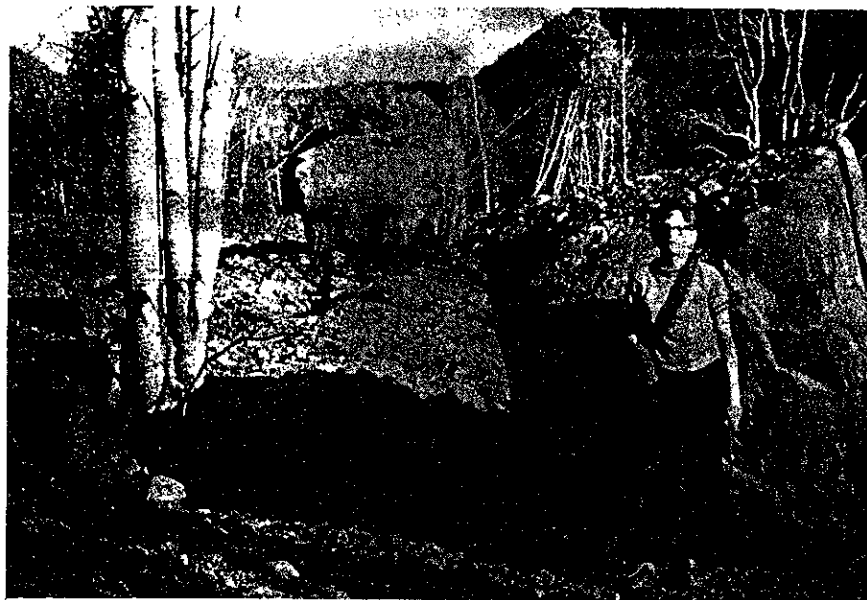
Figure 3. Large blocks of Mesa Verde Sandstone in recent mudflow debris of Slate Creek, twelve year old boy in foreground. Recency of deposit indicated by fine debris on top of blocks.

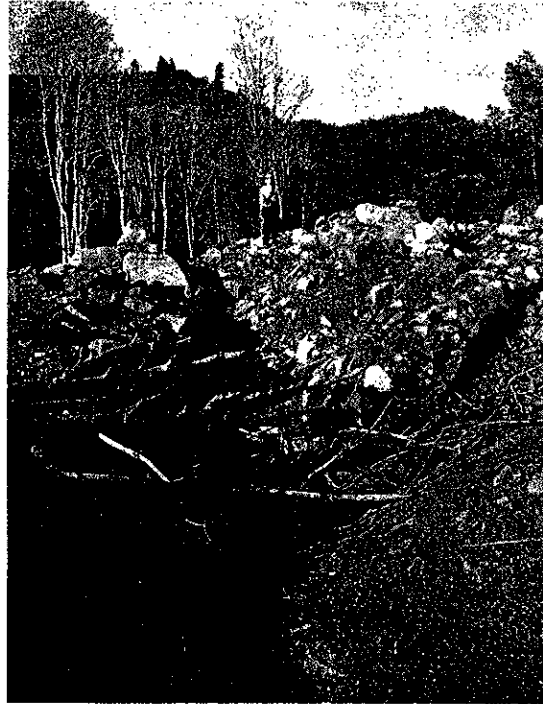
Figure 8. Abandoned channel and mudflow debris in subdivided land of recent Slate Creek mudflows. Boy is standing by the same lot corner shown in figure 7.

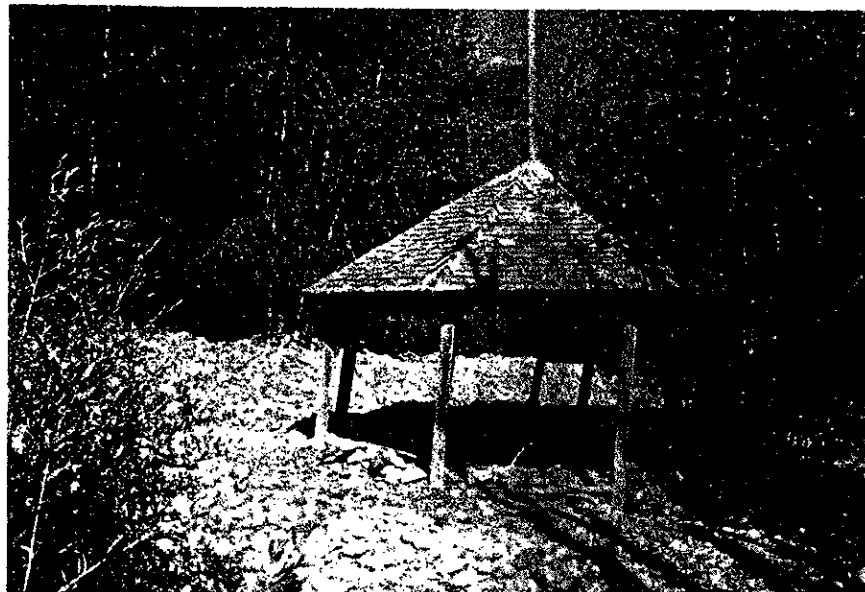
canyon and the Crystal River has a history of similar but much larger mud floods than those described on Slate Creek (figure 9, and plate 1). The area affected by periodic recent mud floods from Carbonate Creek covers approximately twice the area of the Slate Creek flows (2b, plate 1). The most recent catastrophic mud floods on Carbonate Creek occurred in 1936, 1941 and 1945, and smaller floods are reported nearly every year. This area of active mudflow hazard is within the townsite of Marble; however, we believe that construction activities related to recreational, residential, or other development anywhere within the watershed of Carbonate Creek could profoundly increase the threat of mud and water flooding in the lower reaches of Carbonate Creek. In addition, it is possible that a major landslide from the slopes of Mt. Daly or the steep shale bluffs west of Carbonate Creek could divert the creek to another course over the older mudflow fan. Photogeologic studies and limited field inspection of the steep basin rim between the north end of Gallo Bluff and Mt. Daly indicate active as well as old mudflows and potential debris avalanches which are additional reasons for carefully evaluating the water and mud flood potential of the entire drainage basin as a part of any proposed construction or development.

Figure 9. Top of park bandstand in town of Marble, lower part was buried by coarse mudflow debris of 1945 mudflood on Carbonate Creek.

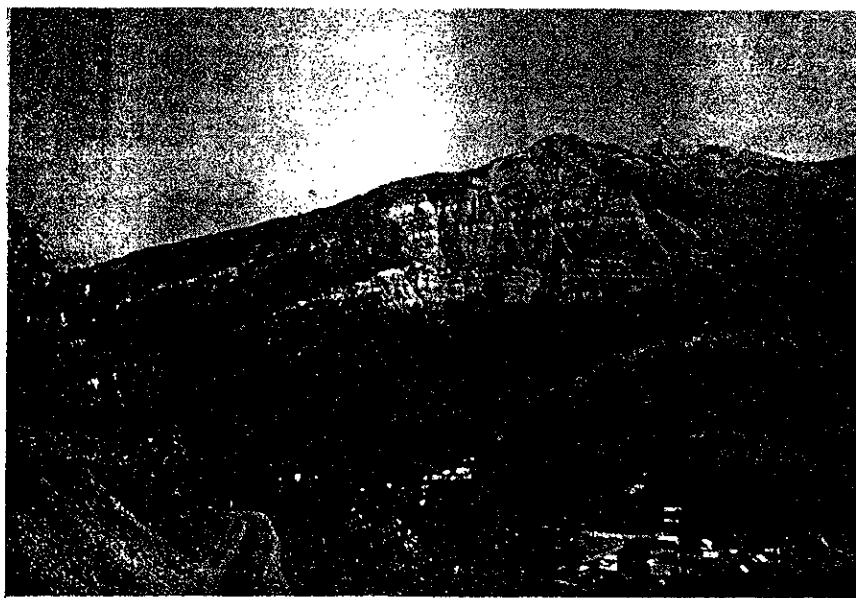
Figure 10. Large unvegetated scar in background is Gallo Bluff. Bare scarp in right center is Mancos Shale on the west bank of Carbonate Creek. Town of Marble in right foreground.

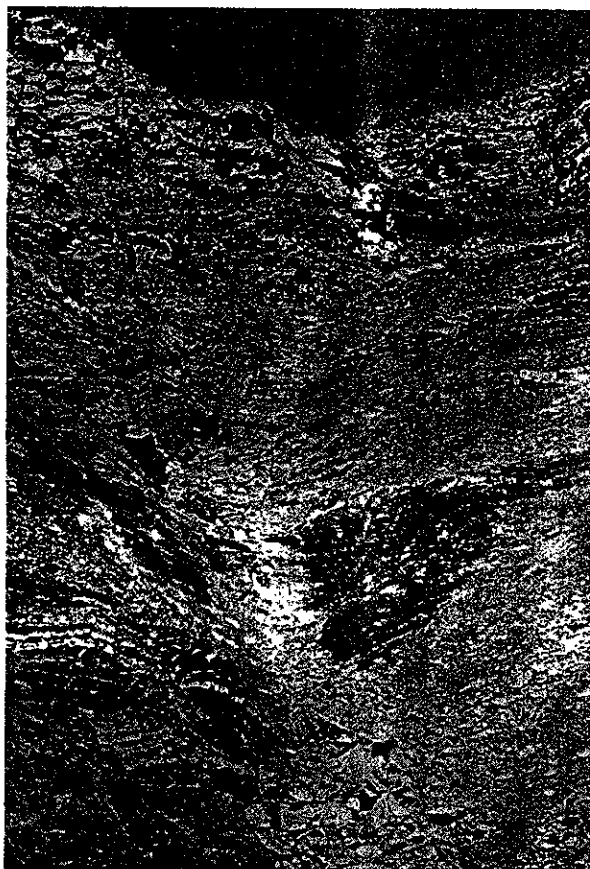
sist of stacks of loose, joint-bounded blocks which are precariously unstable when undercut by erosion (figures 12, 14, 15, 16). This situation gives rise to the constant minor rockfalls which can be precipitated by a gust of wind or another falling rock. Evidence of larger scale instability in the cliffs can be seen in the weathered and open joints which, in many cases, form fissures several tens of feet back of the cliff face (figures 13, 17). These are especially prominent in projecting points in the cliff which form between adjacent gullies. Such gullies or re-entrants in the cliffline tend to follow minor faults which are oriented at approximate right angles to the cliffline. The precipitous gullies on Gallo Bluff, and also those in the Carbonate Creek watershed that lie between the north end of the bluff and Elk Mountain, are locally choked with coarse rock rubble at a precarious angle of repose. The currency and active nature of cliff retreat is shown by still-green trees that can be seen along with rubble in the steep gullies (figure 12).

Figure 12. Typical gully on face of Gallo Bluff. In background, loose overhanging sandstone blocks can be seen. Dark color just below center is from water seepage. In lower center, note loose rock rubble and recently fallen tree.

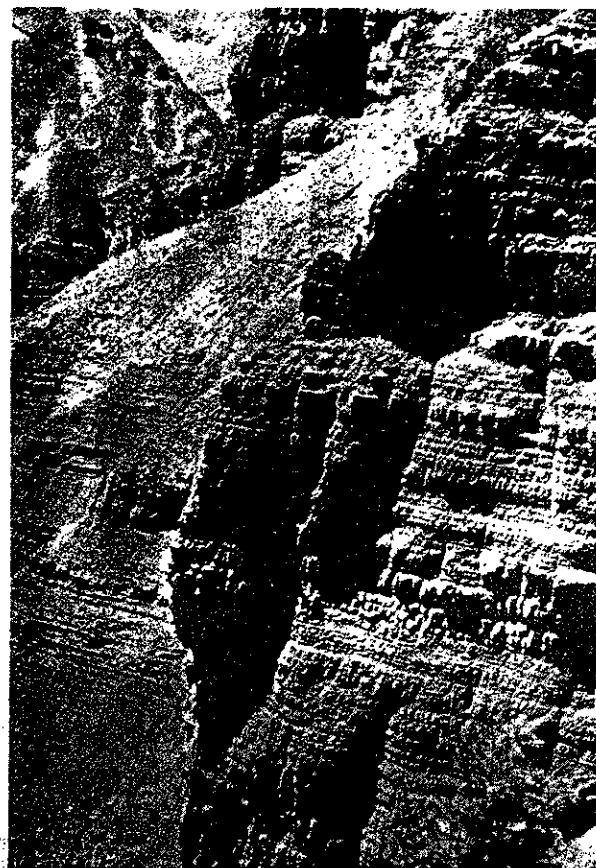
The above described processes produces a general "Grand Canyon" type of topography with waste slopes of shaley debris alternating with nearly vertical ledges of broken sandy shale or sandstone (figure 13). The average slope of the highest part of the cliff is approximately 36 degrees, or 75%. At this location, the bluff has 1,400 ft. of vertical rise in 1,900 ft. horizontal distance.

Figure 13. Typical appearance of middle part of Gallo Bluff. More resistant sandy beds stand near-vertical with numerous open and weathered joints back of cliff face.

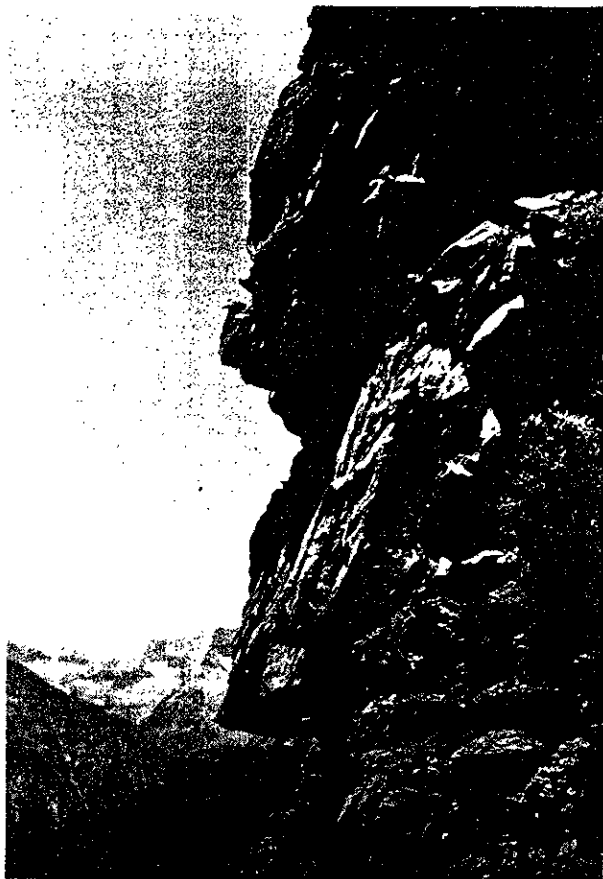
Figure 16. Overhanging ledges of broken and fractured Mesa Verde Sandstone in upper part of Gallo Bluff.

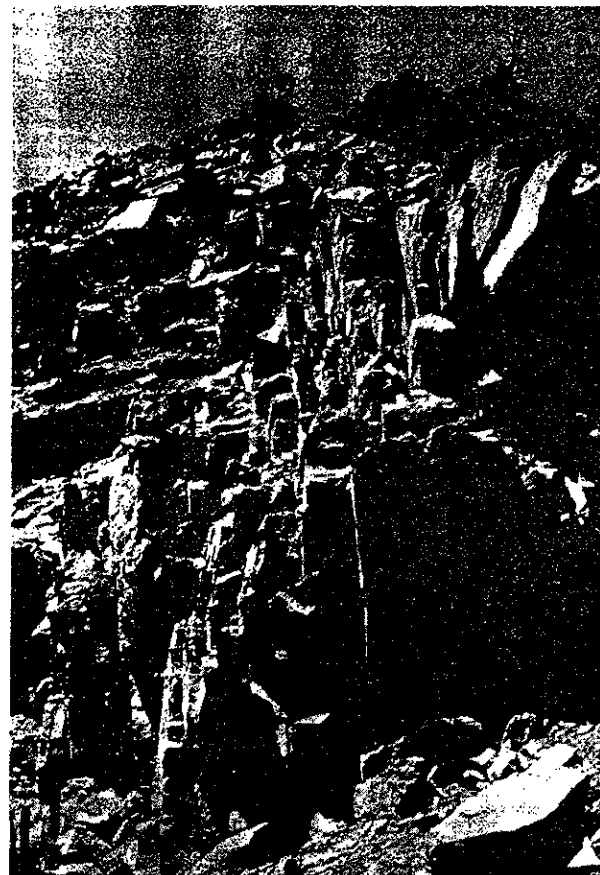
Figure 17. Strongly jointed Mesa Verde Sandstone on ridge just above Gallo Bluff.

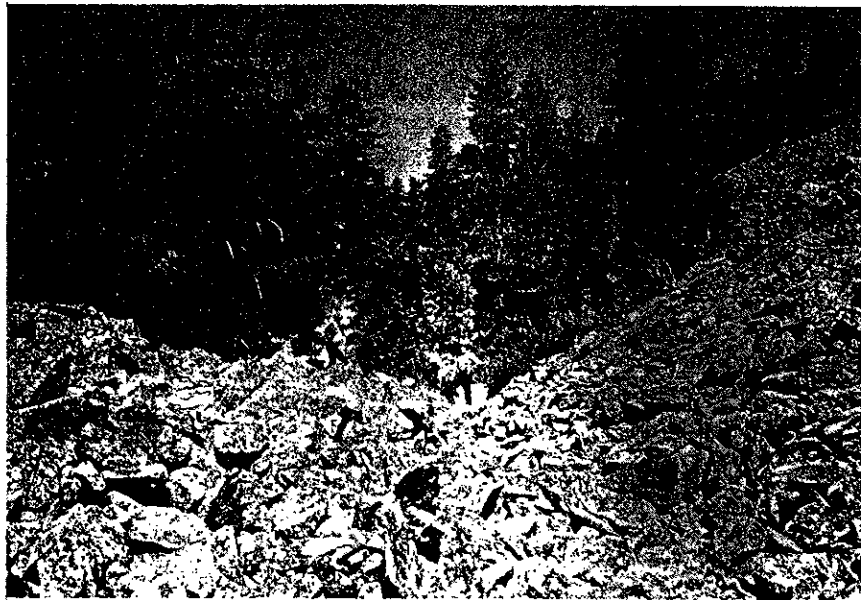
Figure 18. Corrugated surface of coarse talus produced by landslide movements within the talus (area 5 of text).

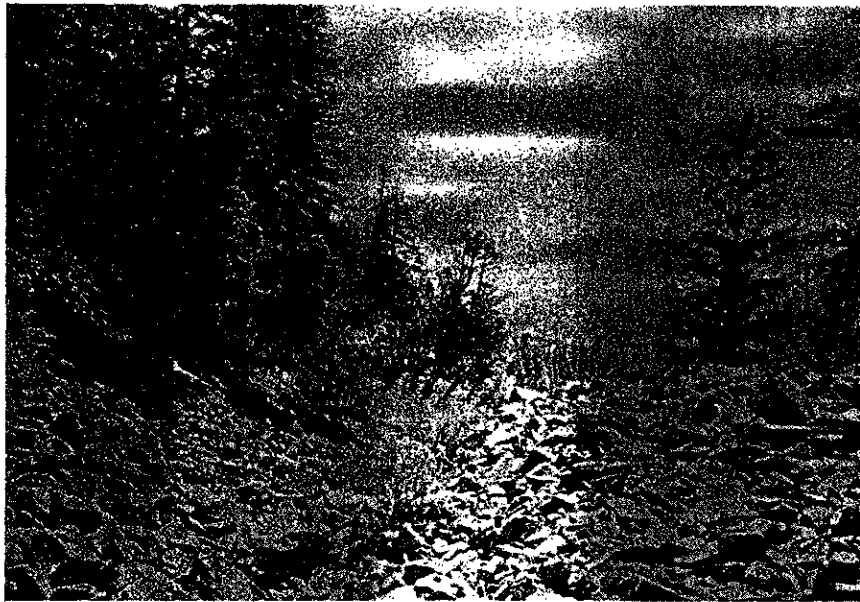
Figure 19. Same general area as above but showing tilting of trees indicating recent movements.
